Law Office of James A. Dumont, Esq., P.C.

Re: Docket 17-3550-INV - Request for Immediate Status Conference

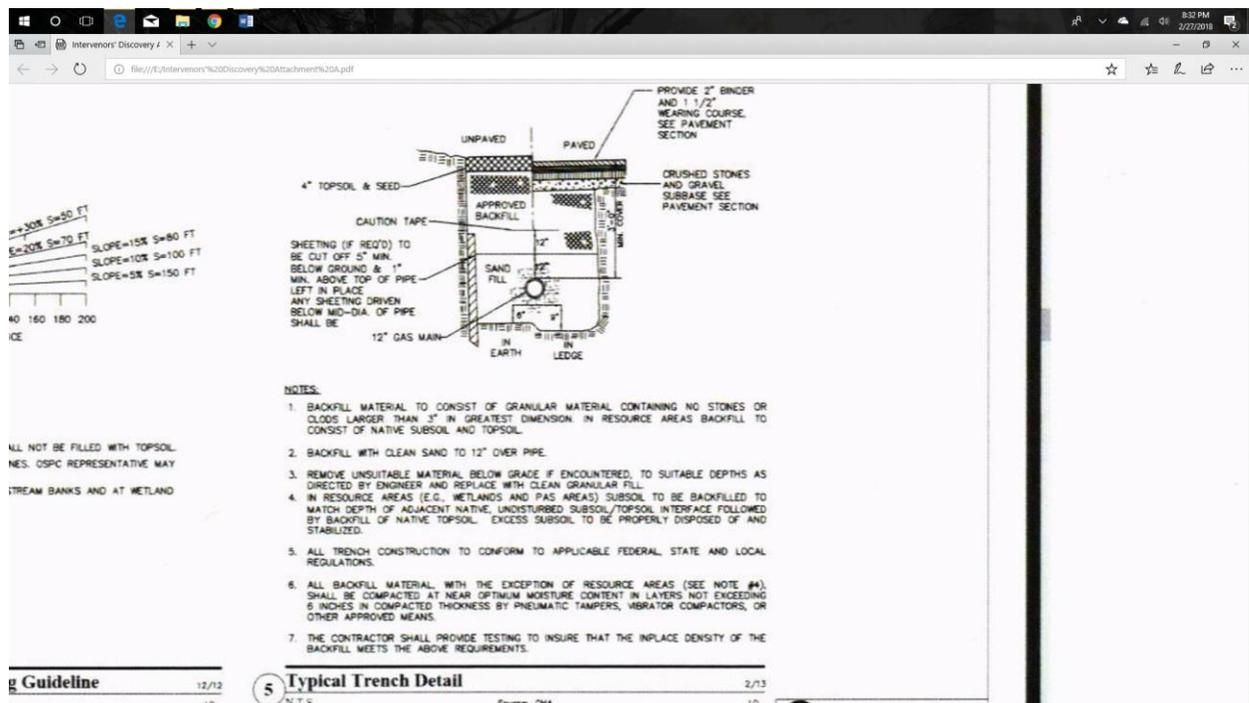
The trench detail plans submitted to the Commission prior to issuance of the CPG², which were incorporated into the CPG, were set forth in Discovery Attachment A and Answer to Request to Discovery Question 1-12 (Agreeing that Attachment A was the trench construction detail plan submitted to the Commission to obtain the CPG.) The details from Attachment A are reproduced here:

The diagram shows the pipe entirely surrounded by “SAND FILL.” It shows a minimum depth of sand fill of 6” on earth trench bottom and 9” on ledge trench bottom. It shows 12” of SAND FILL above the pipe.

Above the SAND FILL its shows “APPROVED BACKFILL.” Note 1 states: “BACKFILL MATERIAL TO CONSIST OF GRANULAR MATERIAL CONTAINING NO STONES OR CLODS LARGER THAN 3” IN GREATEST DIMENSION. IN RESOURCE AREAS BACKFILL TO CONSIST OF NATIVE SUBSOIL AND TOPSOIL.”

The purposes of requiring clean sand or other select backfill under and over the pipe are to avoid abrading the pipe coating, to provide support to withstand loading, and to prevent corrosion. The varying oxygen and moisture of native soils can accelerate corrosion, and nongranular objects can “shield” the pipeline and thereby render Cathodic Protection ineffective. The company did not understand this until the Department explained this to the company in June of 2016. See the previously filed David Berger email to John McCauley June 20, 2016; and the previously filed John St. Hilaire email to GC Morris, July 1, 2016.

And yet, even in its June 21, 2018 report, VGS informs the Department that it found no problem with sites completely lacking sand bedding, completely lacking sand backfill 12” over the pipe, and with backfill riddled with rocks as big as a half foot in length. Other than noting that a scratch in the coating was found at the second location, the June 21, 2018 report concludes that no problems were found at either location.
